Manhole Inspection Summary

Manhole # S09A1_010MH

Location Address: **1261 Harverhill RD**

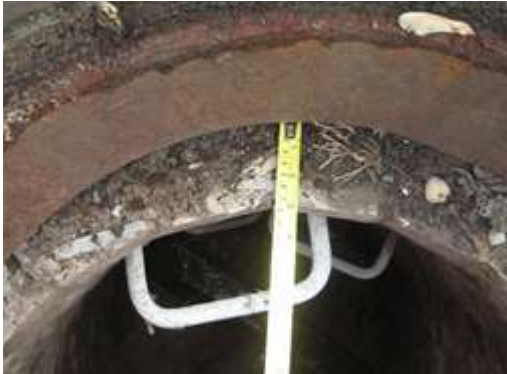
offset

Offset: **3** (in.)

3 inches

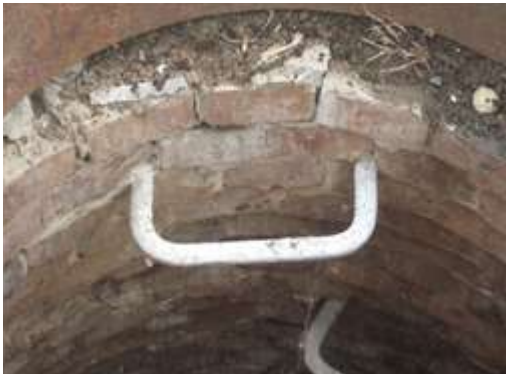
Defect 1

Comments **missing mortar chimney no signs of infiltration.**

Condition: ☐ Sound ☐ Cracked ☐ Root Intrusion ☒ **Loose Brick** ☒ **Deteriorated**

missing mortar chimney

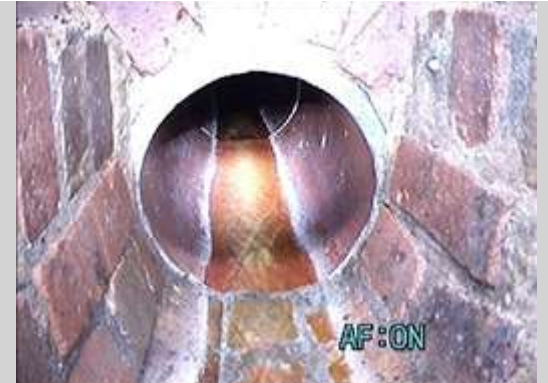
12 O'Clock Outflow

Pipe Height: **8.4** (in.) Rod and Bar (Angled)
Pipe Material: **Clay** ☐ Pipe Lined
Invert Depth: **8.02** (ft.) Flow Characteristics: **Slow**
Deposits: ☒ None ☐ Mud ☐ Sludge ☐ Debris ☐ Grease
Silt Depth: **0** (in.) Deposits Extent:
Infiltration: **None** Pipe Seal Cond: **Sound**

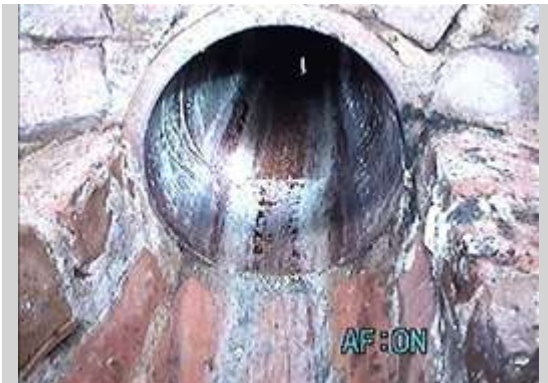
2 O'Clock Inflow

Pipe Height: **8.4** (in.) Rod and Bar (Angled)
Pipe Material: **Clay** ☐ Pipe Lined
Invert Depth: **7.47** (ft.) Flow Characteristics: **Slow**
Deposits: ☒ None ☐ Mud ☐ Sludge ☐ Debris ☐ Grease
Silt Depth: **0** (in.) Deposits Extent:
Infiltration: **None** Pipe Seal Cond: **Sound**

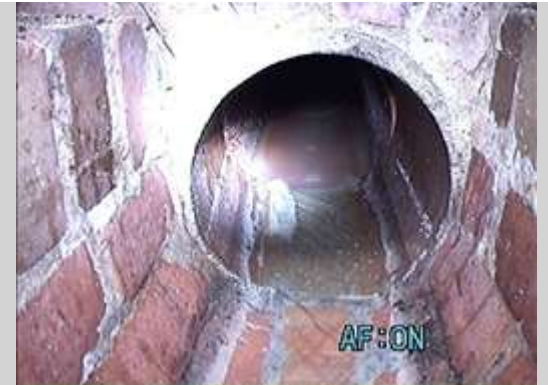
6 O'Clock Inflow

Pipe Height: **8.4** (in.) Rod and Bar (Angled)

Pipe Material: **Clay** ☐ Pipe Lined

Invert Depth: **7.90** (ft.) Flow Characteristics: **Slow**

Infiltration: **None** Pipe Seal Cond: **Sound**
